# Building Inspection Report

Brookfield, WI 53045

05/2018

Shamrock Building Inspection Consultants LLC

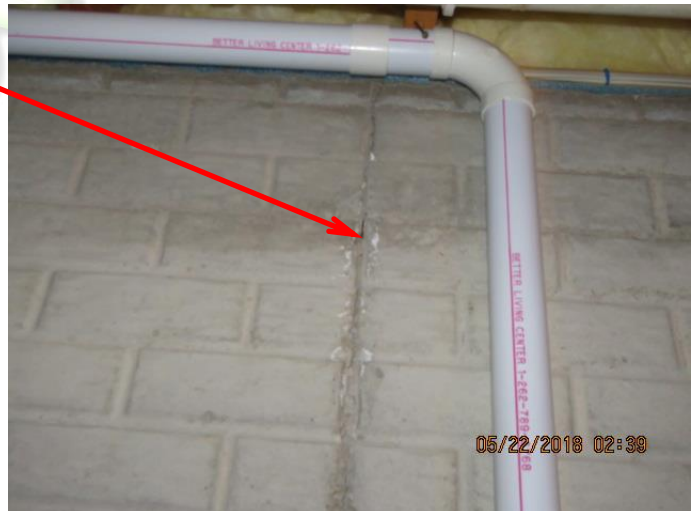
- **Monitor:** Common minor cracks were observed on the exterior walls of the house in various locations. This implies that structural movement has occurred. The location, size, shape of these cracks is common. The inspection did not find evidence of significant movement requiring immediate major repairs.

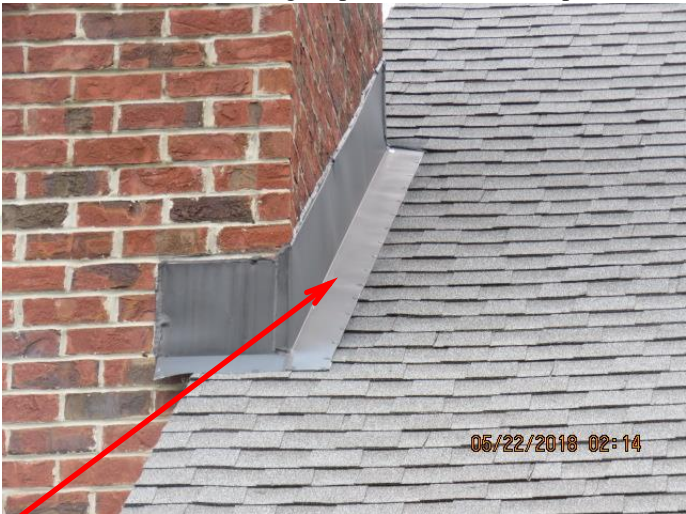
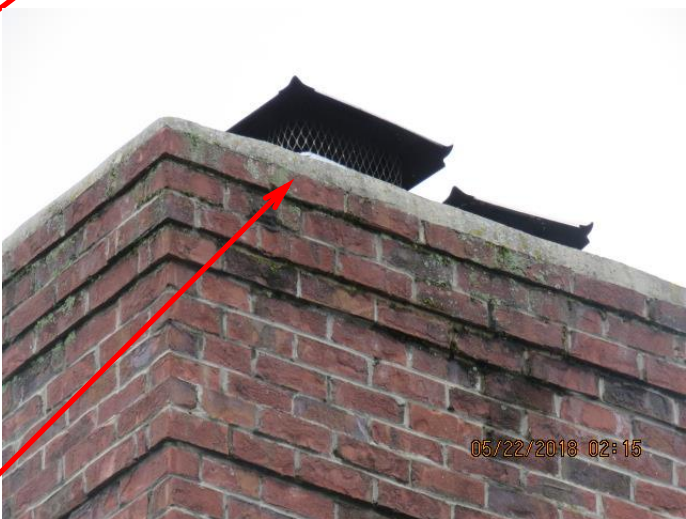
- **Repair:** The cap of the masonry chimney should be replaced with a proper cap that extends 1½ in. beyond the brick to protect the brick from water damage. The chimney flue should be checked for damage. Damaged flues can be unsafe.

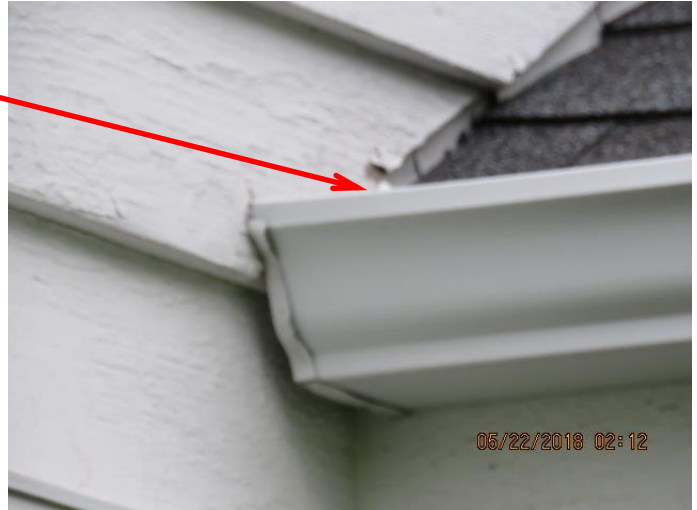
- **Monitor:** The downspouts that discharge below grade level on the entire house should be monitored. If they are ever suspected to be clogged or disconnected below grade, they should be redirected to discharge at least five (5) feet from the building. Foundation leakage adjacent to a downspout is an indication of a problem below grade.
- **Repair:** Downspout(s) that discharge onto the roof at the rear slope should be extended to discharge directly into the gutters below. This condition, if left unattended, can result in premature deterioration of the roofing under the end of the downspout.
- **Repair:** The installation of the kick out flashing is incomplete and should be repaired to avoid leaks. Kick out flashing should be installed to divert roof water into the gutter, and away from the roof wall joint.

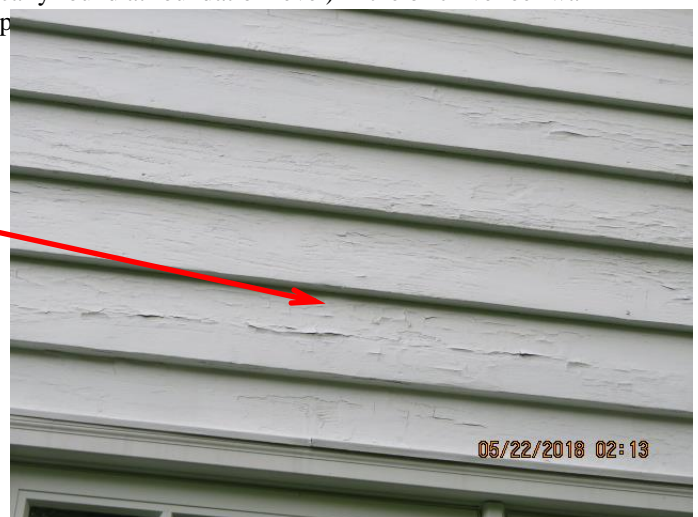
- **Repair:** The soffit vents are painted closed. This will reduce the attic ventilation significantly. These vents should be replaced to promote proper soffit ventilation.

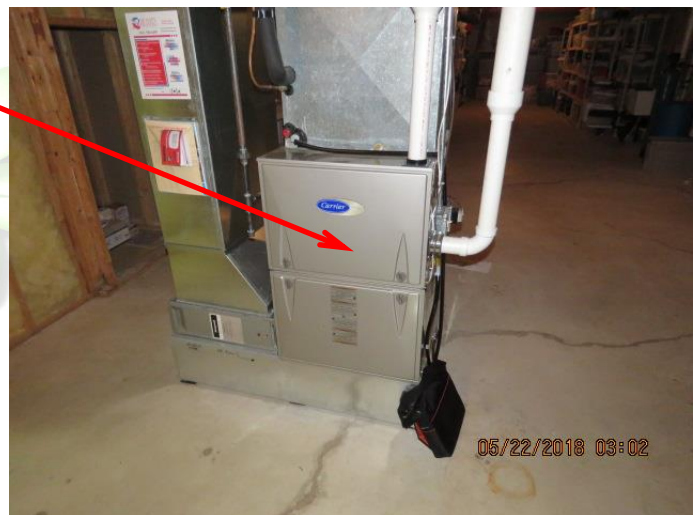
- The heating system was tested for CO with a Testo - 325 CO meter and the level was 13 ppm. For most furnaces and boilers 80 PPM or lower is considered normal operating condition. CO levels over 100 are a safety issue and should be evaluated by an HVAC contractor.
- The furnace was tested and functioned properly at the inspection. A temperature rise test was performed and the temperature rise was within the normal range. A temperature rise test is the temperature difference between the supply air and the return temp at the plenum.

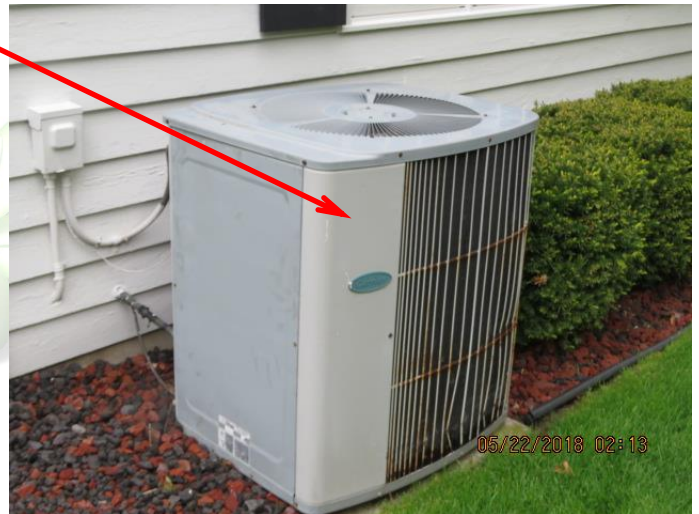
- **Deferred Cost Item:** As is not uncommon for homes of this age and location, the air conditioning system is relatively old. It will require a higher level of maintenance, and may be more prone to major component breakdown. Predicting the frequency or time frame for repairs on any mechanical device is virtually impossible. If the compressor fails, or if breakdowns become chronic, replacing the entire system may be more cost-effective than continuing to undertake repairs.
- **Repair:** Damaged and/or missing insulation on refrigerant lines should be repaired. These outside lines should be insulated all the way to the compressor unit to prevent loss of temperature in the lines.

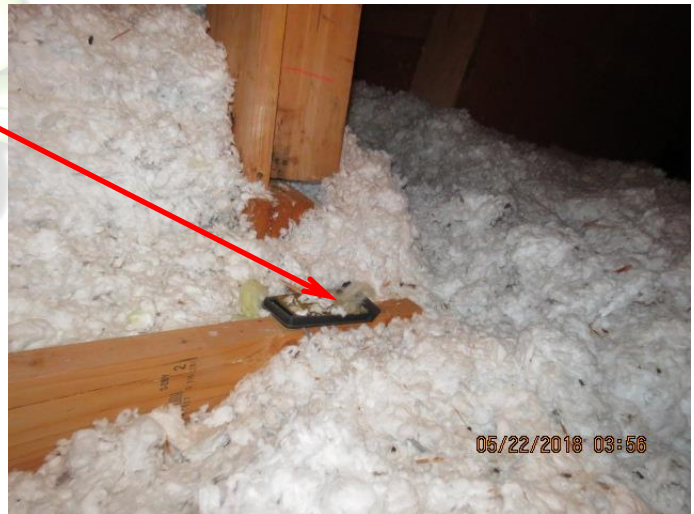
- **Repair:** Disturbed insulation in the main attic should be repaired or evened out.
- **Repair:** There is evidence of vermin activity in the main attic. A pest control specialist should be consulted in this regard.

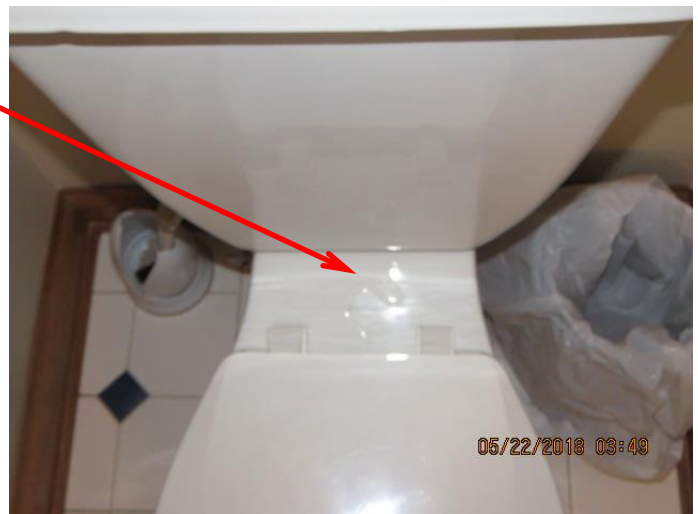
- **Repair:** The shower head in the main floor bathroom is in poor condition.
- **Repair:** The toilet tank is loose in the second floor bathroom. Recommend securing to the bowl and replace gasket as needed.
- **Repair:** The toilet is loose in the master bathroom. It should be reset with a new wax ring and properly secured to the floor.
- **Repair:** A ground fault circuit interrupter (GFCI) should be installed on the circuit for the whirlpool bathroom. A ground fault circuit interrupter offers protection from shock or electrocution.
- **Improve:** Access to the whirlpool motor should be provided without damaging the building structure or building finish as per NEC 680.73.

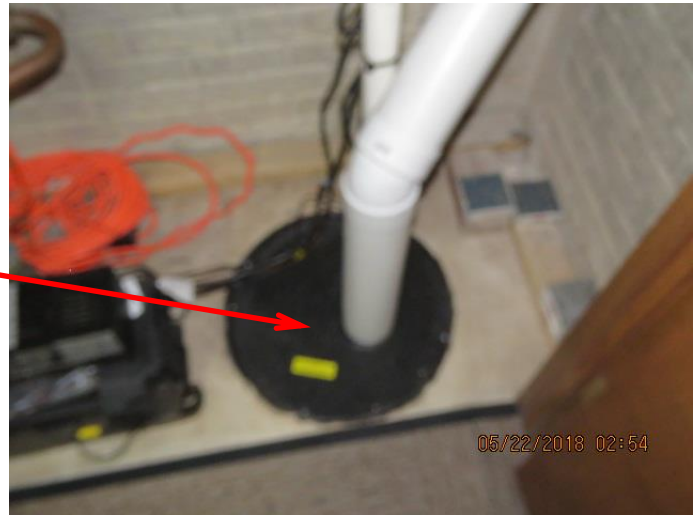
- **Monitor:** The sump pump is old. As with any old mechanical device, its useful remaining life is difficult to predict.
- **Monitor:** Sump pumps by their nature typically last for 1 to 5 years. They should be tested twice a year by pouring a bucket of water into the crock to make sure that the pump functions properly. A nonfunctioning or damaged sump pump can cause the basement to flood.
- **Repair:** The radon mitigation system should have a sealed clear sump crock cover with a removable 4" port for testing the pump. Water levels inside the crock need to be monitored to ensure proper performance of the sump pump. If water levels raise above the drain tile the mitigation system will not function.
- **Repair:** The radon mitigation vent pipe that breaches the firewall in the garage must have a fire collar around the pipe. This is a potential fire hazard and must be addressed promptly.

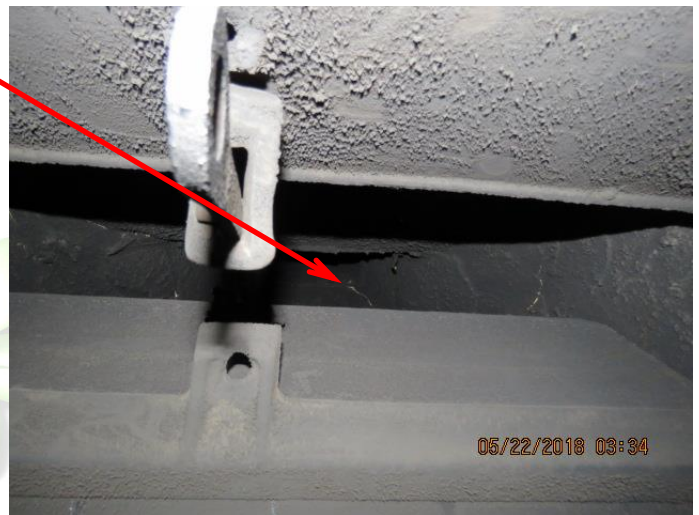
- **Repair:** The fireplace chimney in the family room should be inspected and cleaned prior to operation. There is a crack in the lowest flue.

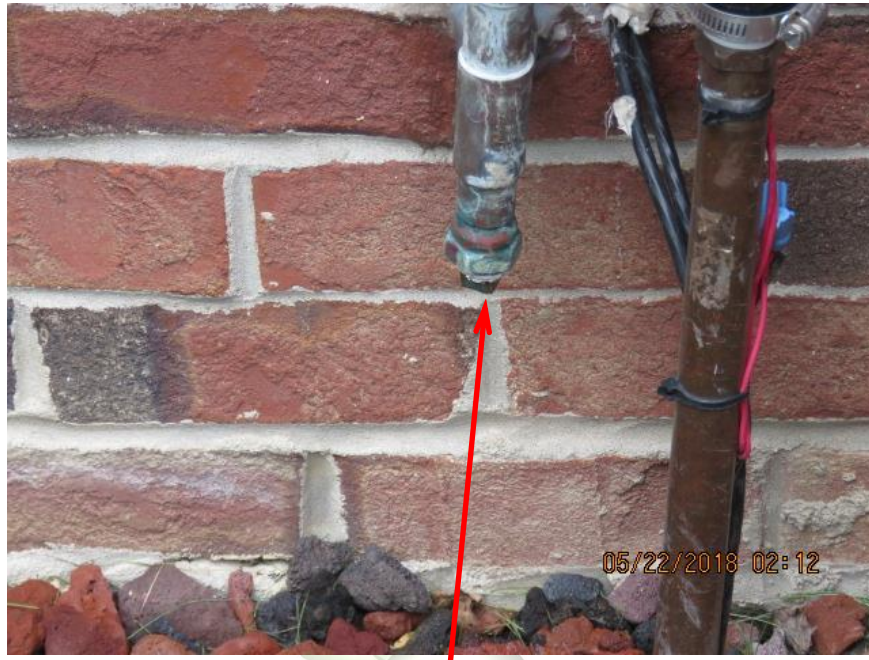
Leak at sprinkler

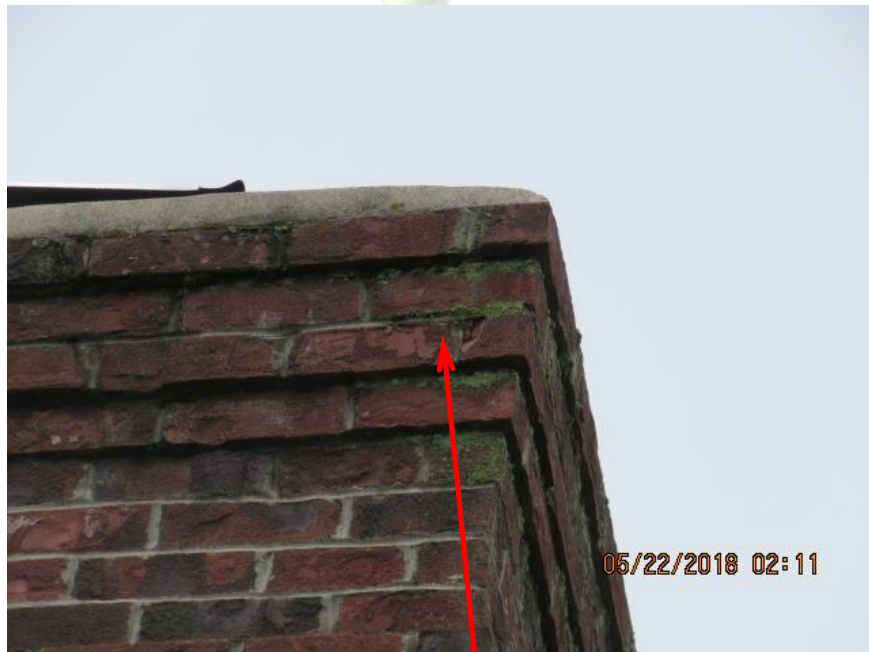
Spalling brick on chimney

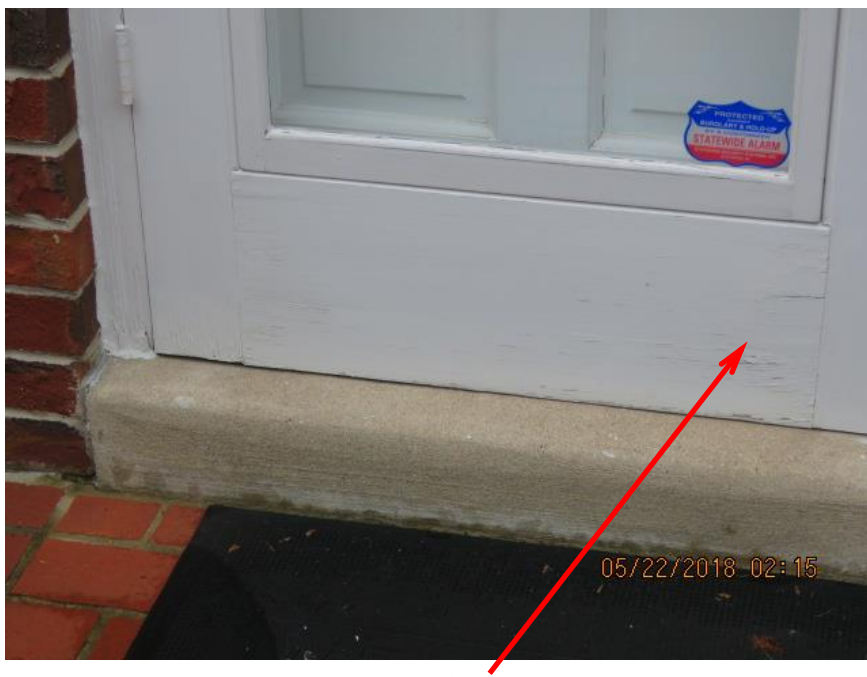
Storm doors need paint

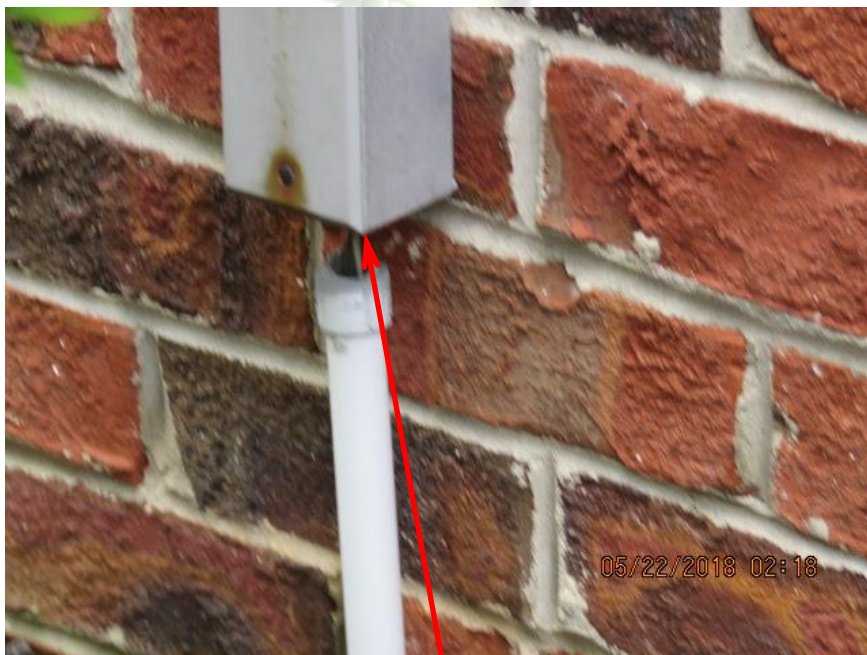
Wiring separated from junction box

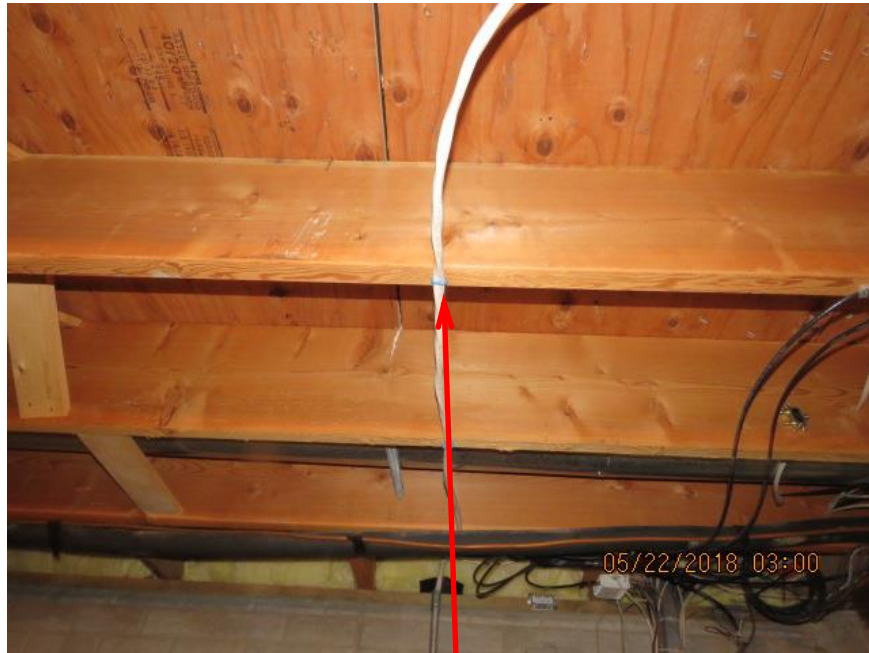
Exposed nonmetallic wiring
