Your INSPECTION REPORT

443 Madison St, Toronto, ON

RE: Report No. 3284, v.6
443 Madison St
Toronto, ON

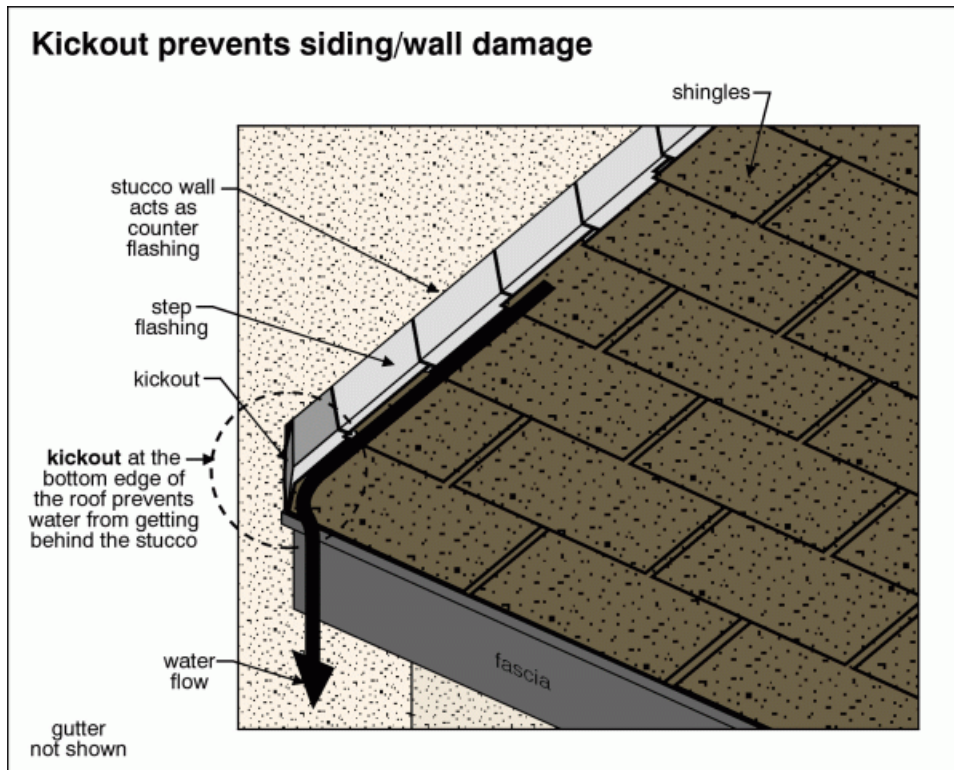
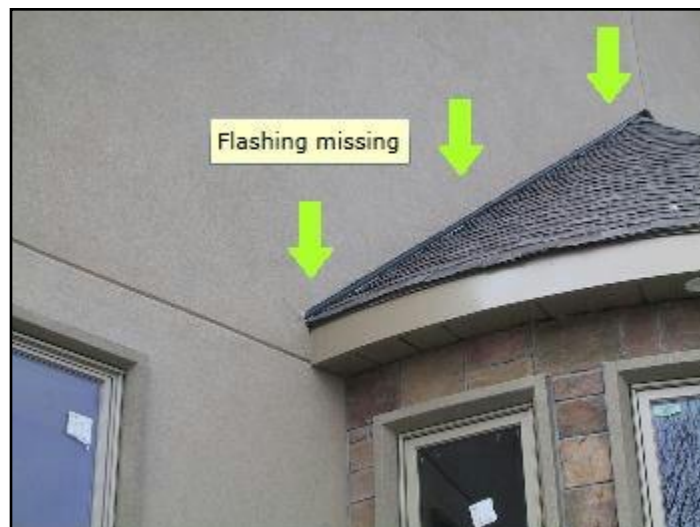
1. Condition: • Kickout flashing - missing

Implication(s): Chance of water damage to contents, finishes and/or structure

No kickout flashing at roof/sidewall junction

Task: Improve

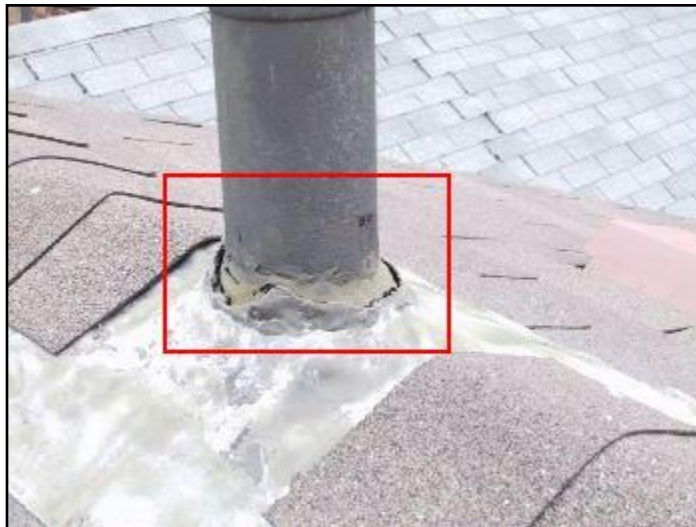
2. Condition: • Leak

Implication(s): Chance of water damage to contents, finishes and/or structure

Leak

Task: Repair

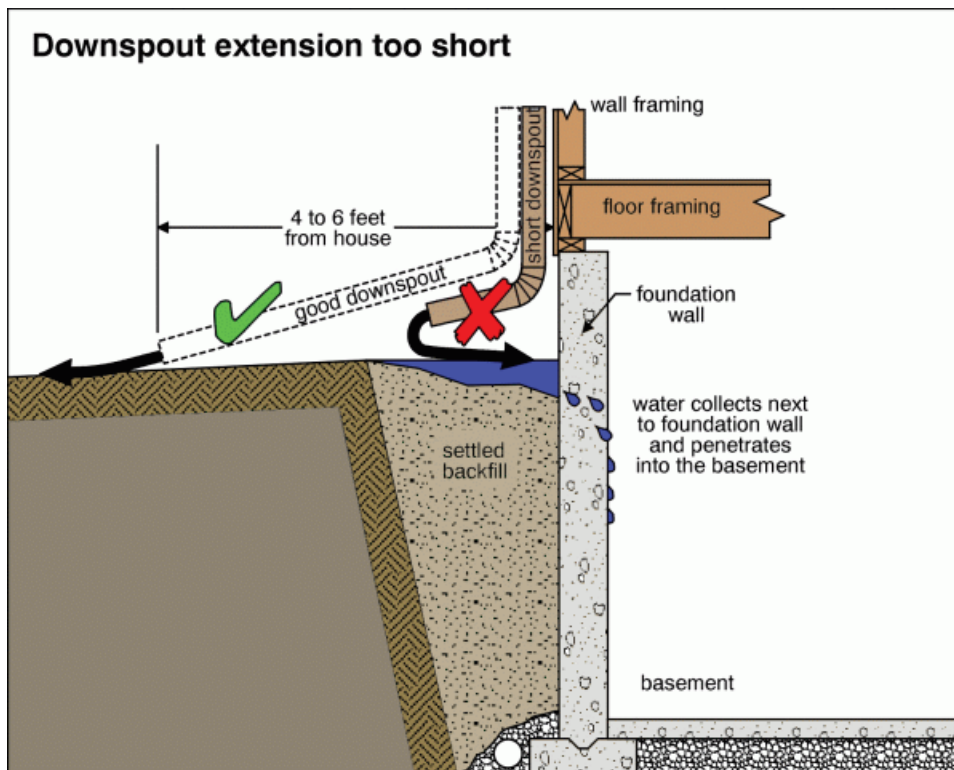
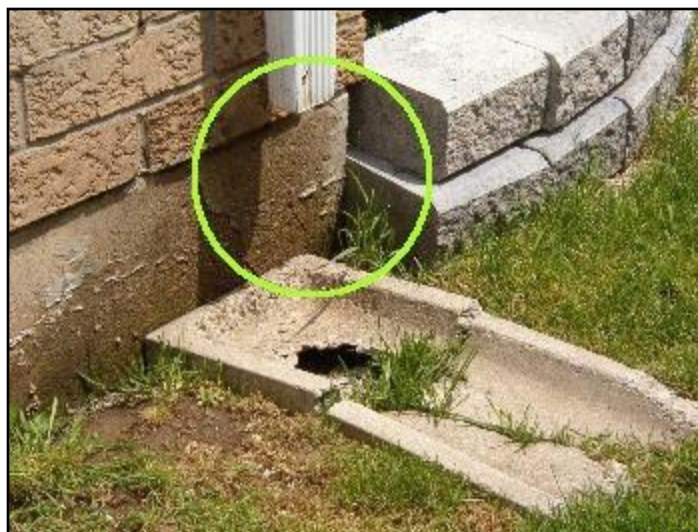
4. Condition: • Discharge too close to building

Implication(s): Chance of water damage to contents, finishes and/or structure

Downspouts discharge too close to building

The downspout should be extended to discharge at least 6 feet from the home. The splash block can be discarded.

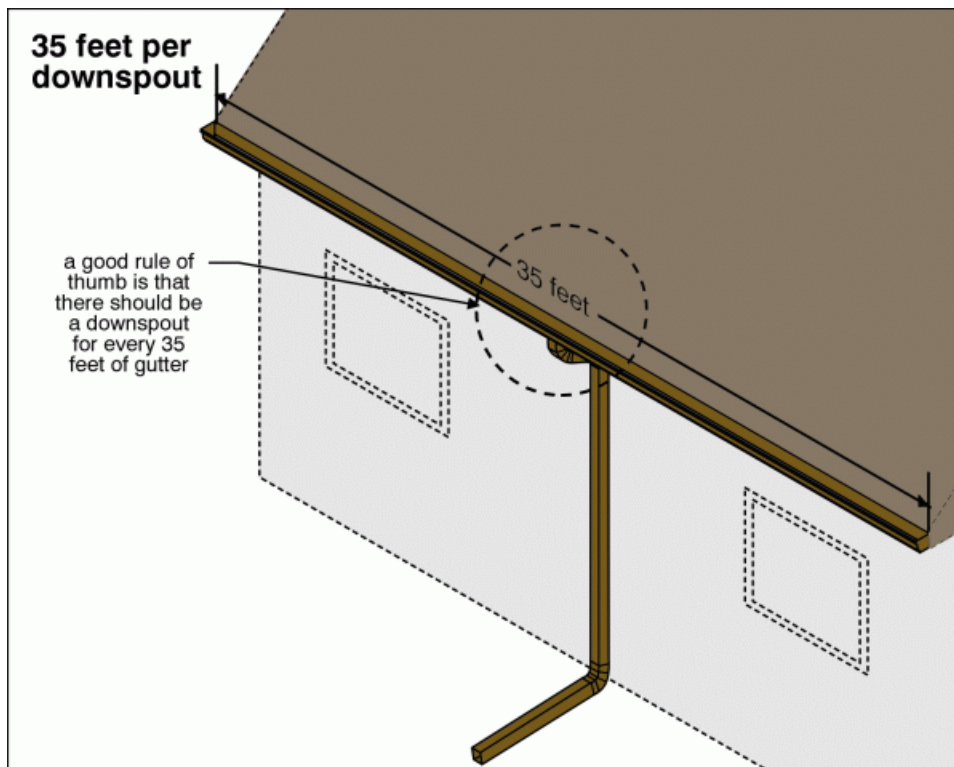
5. Condition: • Too few

Implication(s): Chance of water damage to contents, finishes and/or structure

More downspouts will help reduce the risk of basement flooding.

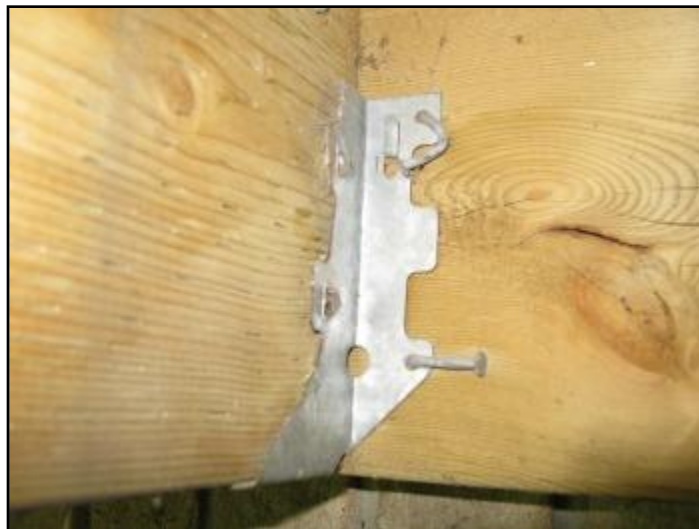
6. Condition: • Fastener problems

Joist hangers for wood deck are not properly secured.

Implication(s): Chance of movement | Weakened structure

Poor end bearing, joist hanger connections

Task: Improve

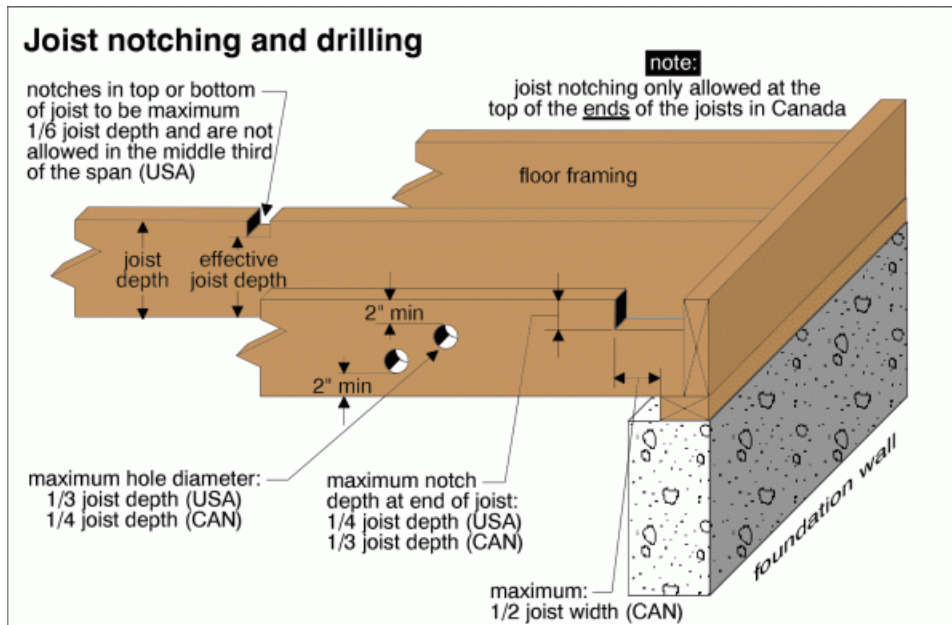
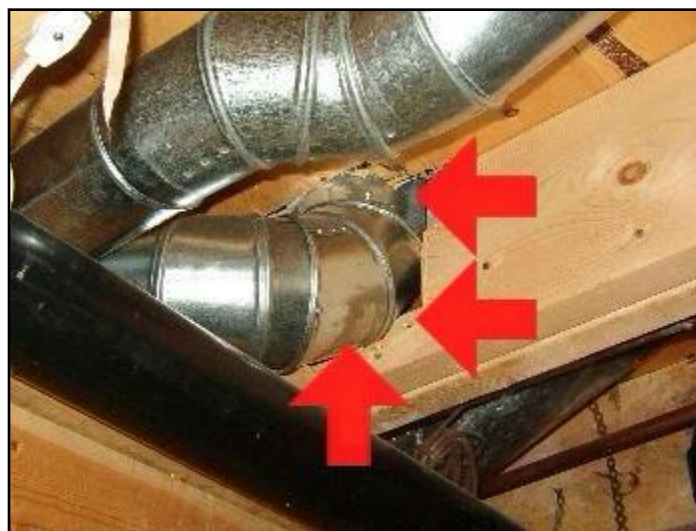
Condition: • Notches or holes

Previous repairs noted.

8. Condition: • Notches or holes

Implication(s): Weakened structure

Joists are notched and weakened

Task: Repair

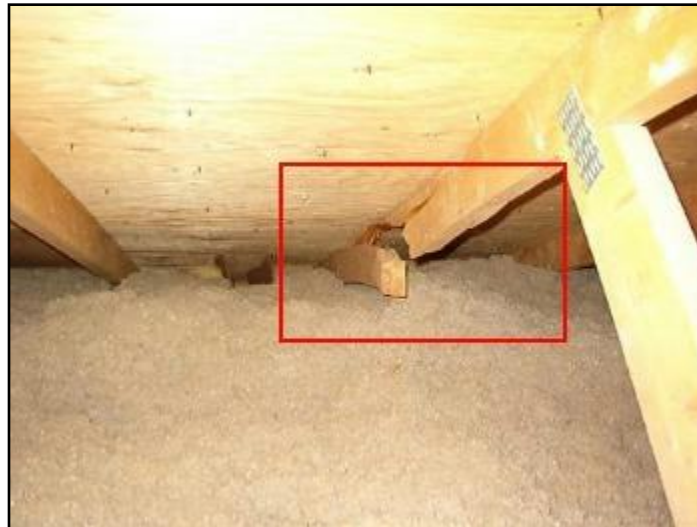
9. Condition: • Split

Implication(s): Chance of structural movement | Weakened structure

Top chord of truss is split

Truss repairs must be designed by an engineer.

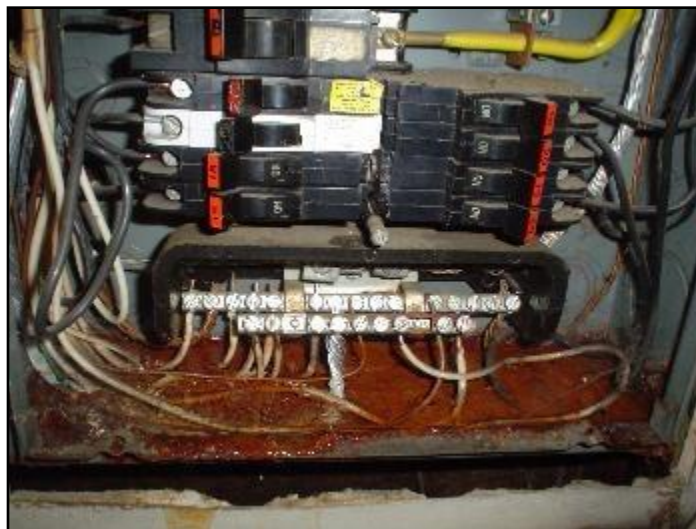
Condition: • Rust or water in panel

Implication(s): Fire hazard | Electric shock

11. Condition: • Rust or water in panel

Water and rust in bottom of panel

Task: Replace

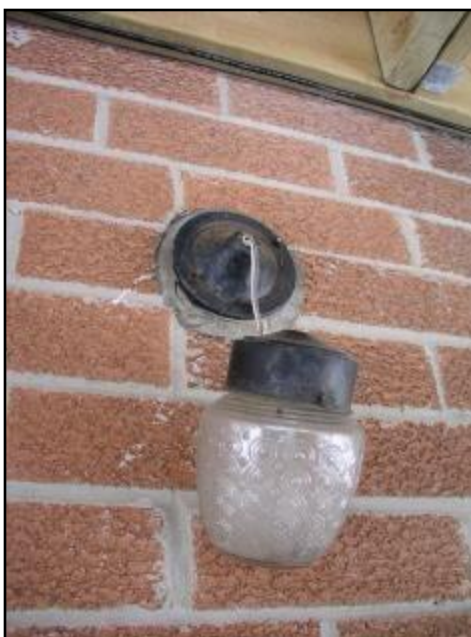
14. Condition: • Loose

Implication(s): Electric shock | Fire hazard

Light fixture is not well secured

Task: Repair or replace

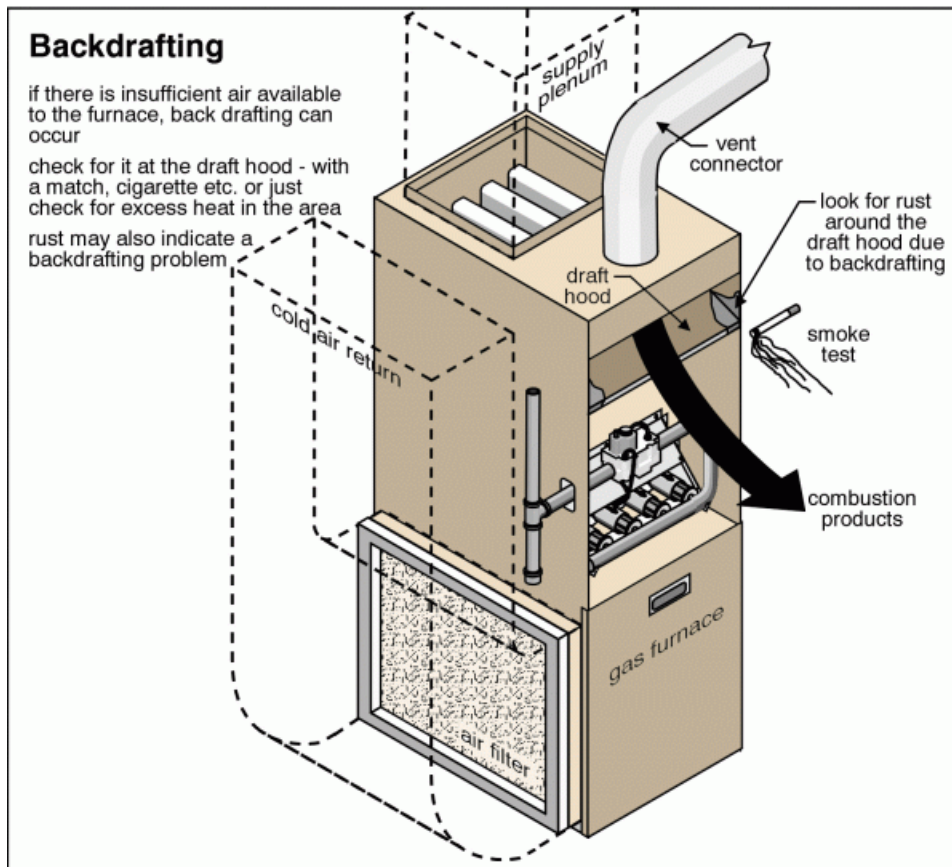
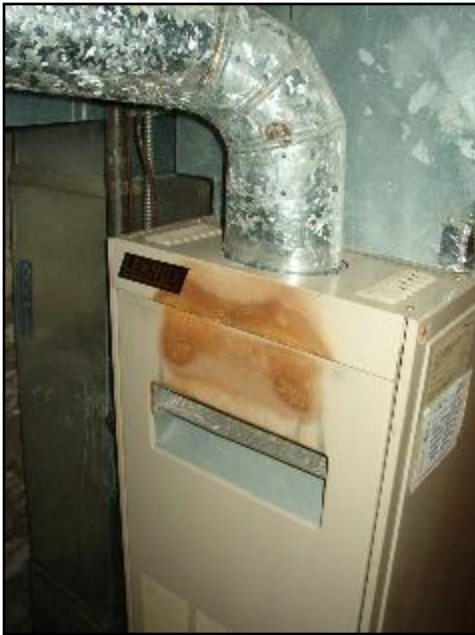
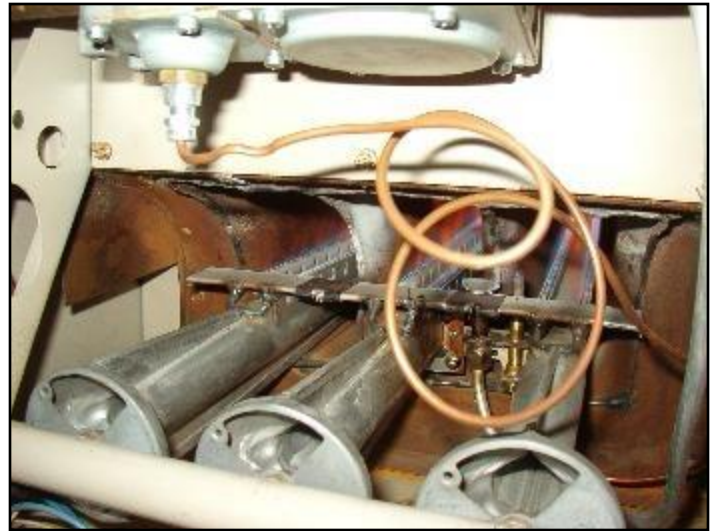
16. **Condition:** • Draft hood spillage or backdraft

A considerable amount of rust was noted on the front of the furnace.

This suggests a back-drafting problem, with combustion products entering the home.

This is often caused by lack of combustion air, but the corrective action should be determined by a specialist.

Implication(s): Hazardous combustion products entering home | Equipment not operating properly

Draft hood spillage or backdraft

Task: Correct

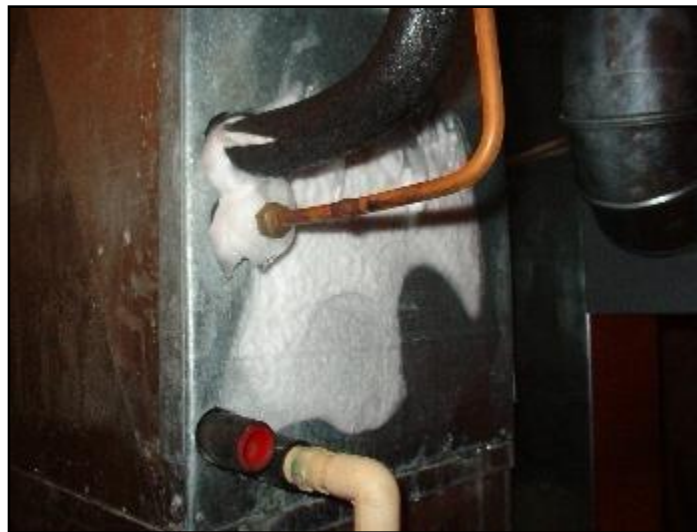
17. Condition: • Frost

Implication(s): Increased cooling costs | Reduced comfort

Frost

Task: Repair

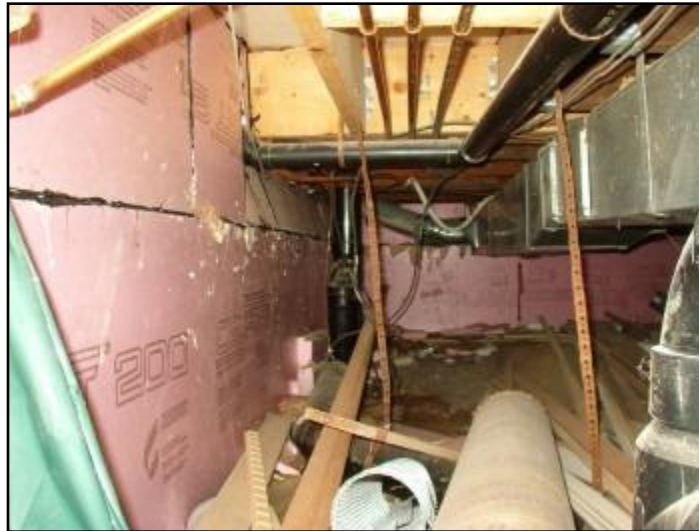
18. Condition: • Exposed combustible insulation

Implication(s): Fire hazard

Exposed combustible insulation

Task: Remove or cover with drywall

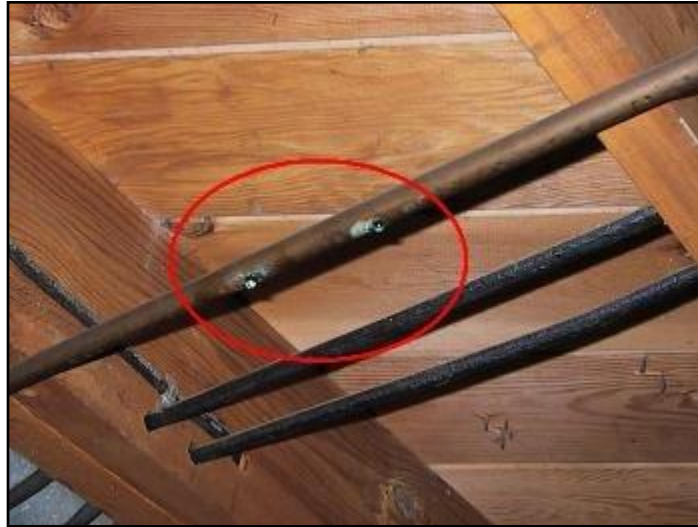
19. Condition: • Leak

Task: Replace

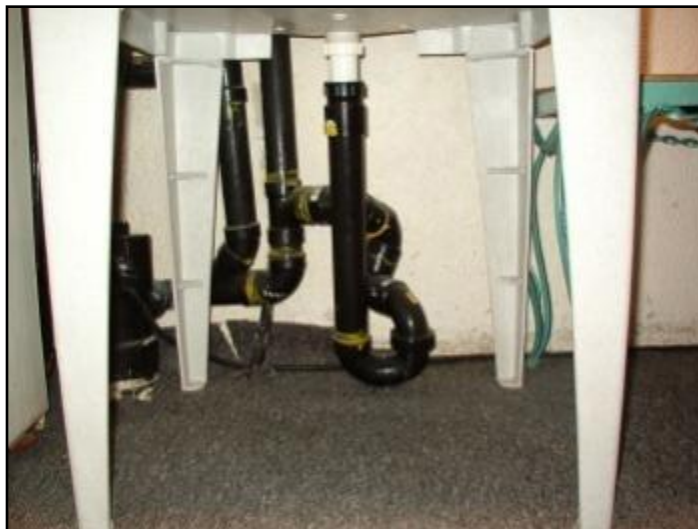
20. Condition: • Nonstandard shape or material

Implication(s): Fixtures slow to drain | Reduced operability

Poor trap arrangement

Task: Improve

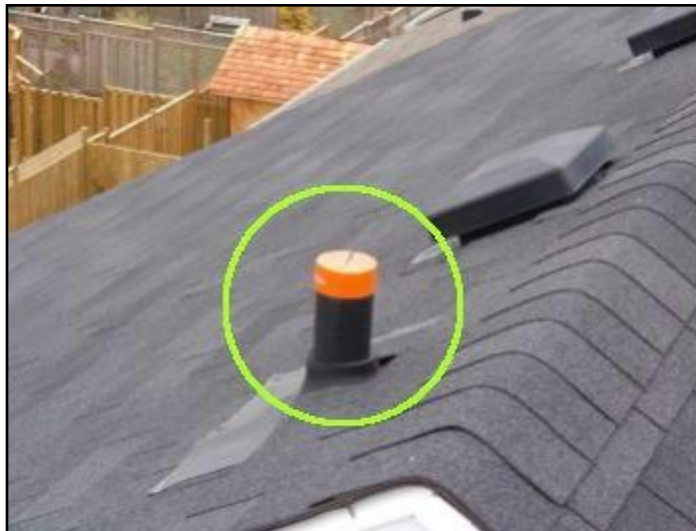
21. Condition: • Vent termination problems

Implication(s): Sewer gases entering the building | Reduced operability

Plumbing stack is capped

Task: Remove cap

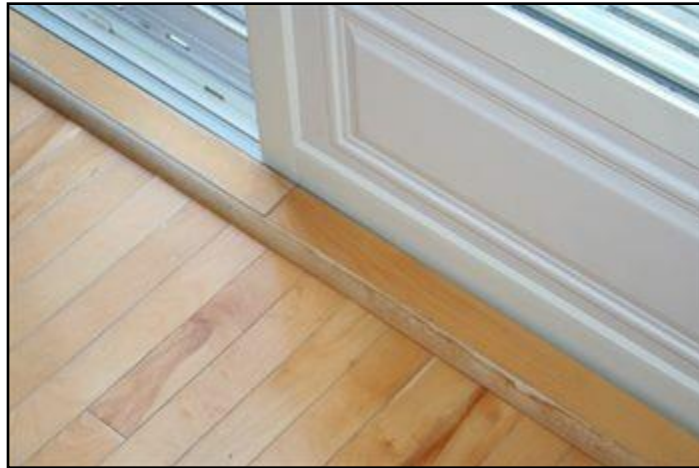
22. Condition: • Stained

Implication(s): Chance of water damage to contents, finishes and/or structure

Stained

Task: Replace

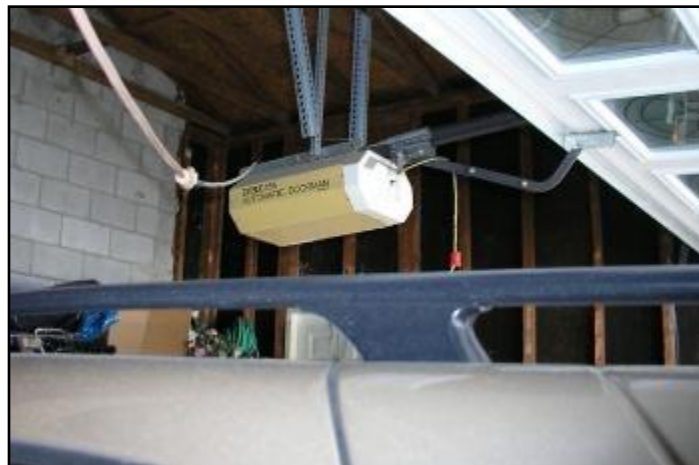
23. Condition: • Extension cord for opener

Implication(s): Electric shock

Extension cord for opener

A dedicated receptacle (outlet) is recommended for the door opener.
